MAPPING SHORELINE VULNERABILITIES USING KITE AERIAL PHOTOGRAPHS AT OLUVIL HARBOUR IN AMPARA

B.D. Madurapperuma^{1,2}, J.E. Dellysse², I.L.M. Zahir³ and A.L. Iyoob⁴

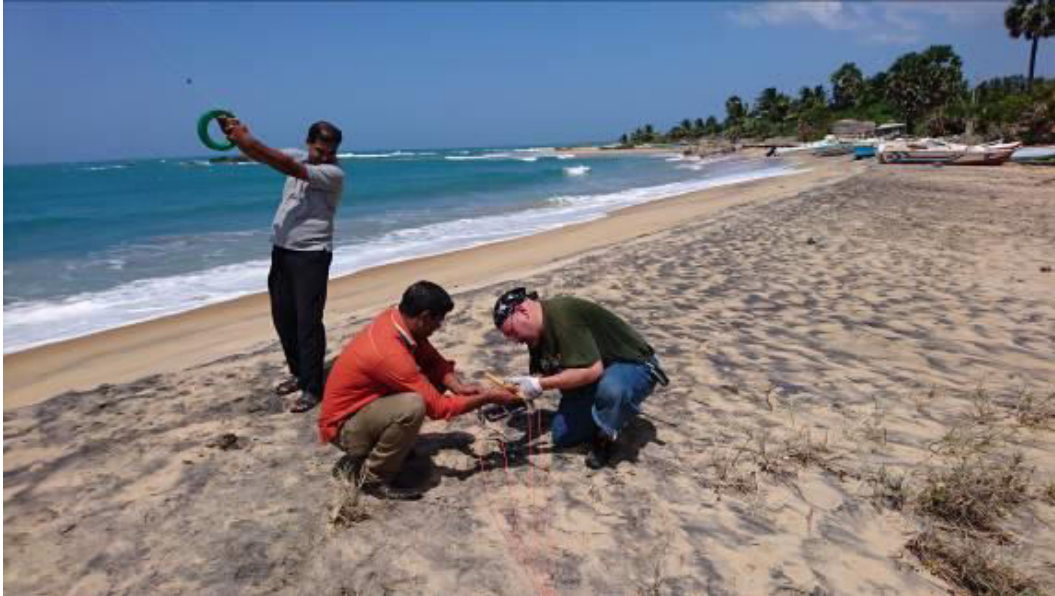
Fig. 1. Set up Picavet stabilizing rig with two cameras

A KAP platform was created using two light-weight automatic cameras with dual bandpass Red-NIR filters, Picavet stabilizing rig, GPS tracker and a Parafoil kite. Two cameras, one RGB camera and the other camera with Red-NIR filters were set together to take images synchronously (Figs. 1 & 2). The high resolution KAP images were processed to build mosaic images, orthorectified and georeferenced DEMS using

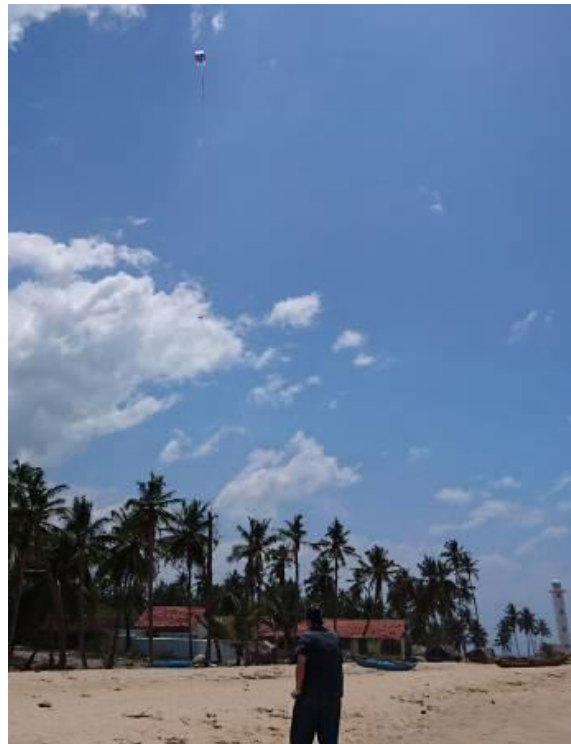
Fig. 2. A kite up in the air at Oluvil beach

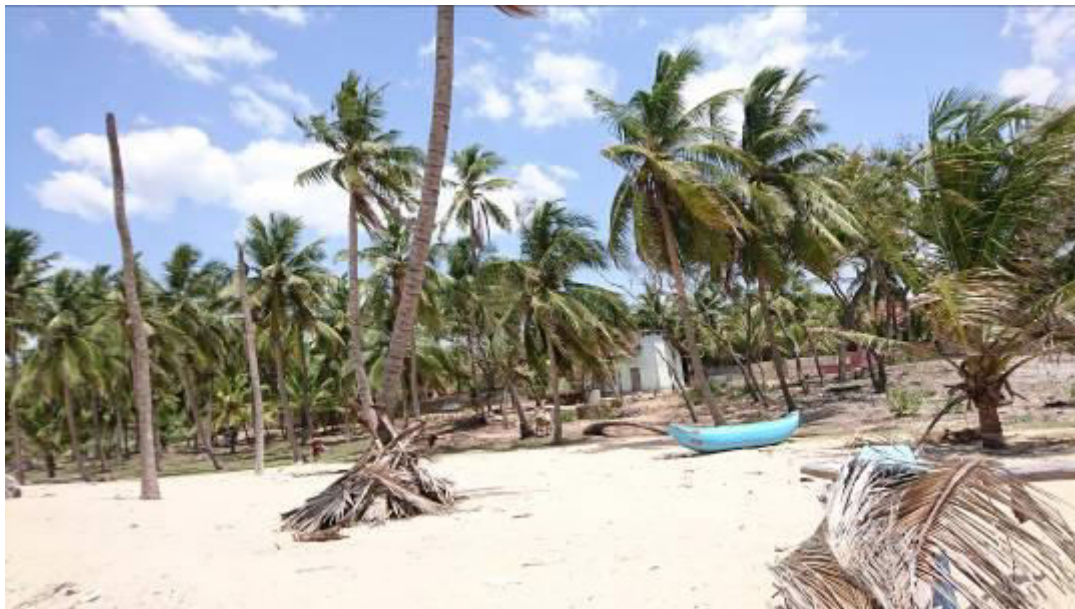
Fig. 5. The coconut plantation at the Oluvil beach

NDVI is a good indication of vegetation bioshield mass estimation and vegetation health. The NDVI values along the coast ranged from 0 to 0.4 and the coconut plantation has been shown to have the highest NDVI values (Fig. 4). The coconut plantation showed a lean distribution along the coast and some trees were weak due to severe erosion (Fig. 5). This may have contributed to relatively low NDVI values for coastal vegetation.

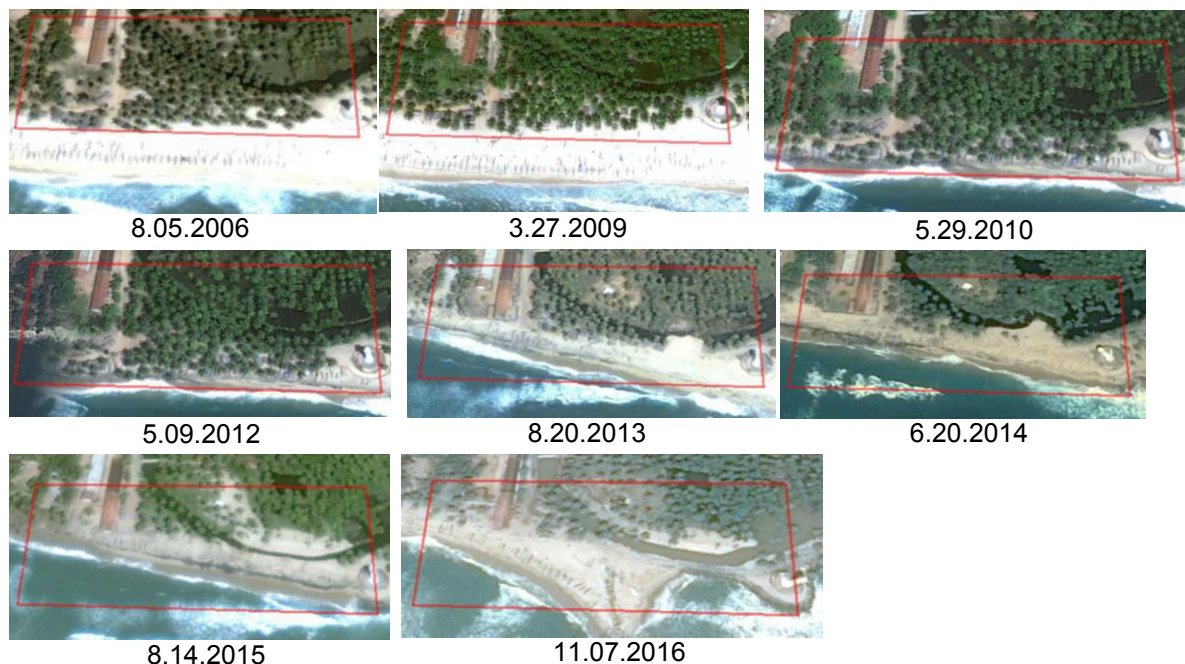
Fig. 6. Historical coastal land-use change in Oluvil beach resulting in severe erosion. A red bounding box has shown the sample area

A historical land-use change at Oluvil beach observed using Google Earth images (Fig. 6). As the boundary of the study area boundary (a red minimum bounding box in Fig. 6.) showed a significant reduction of coastal land mass especially from 2010 to 2016. The shoreline has been cut off towards the inland areas where those periods and notable vegetation changes was observed from 2013 to 2016. There was not much coastline change in 2006 and 2009 although Oluvil Harbor started in 2006. However, Ameer (2015) reported that harbor construction during 2006 to 2009 caused erosion resulting in more land retreated into the sea.
